Phénomènes observables sur la coupe transversale d'un trou métallisé

Phenomena in Cross Section of Plated Through Holes

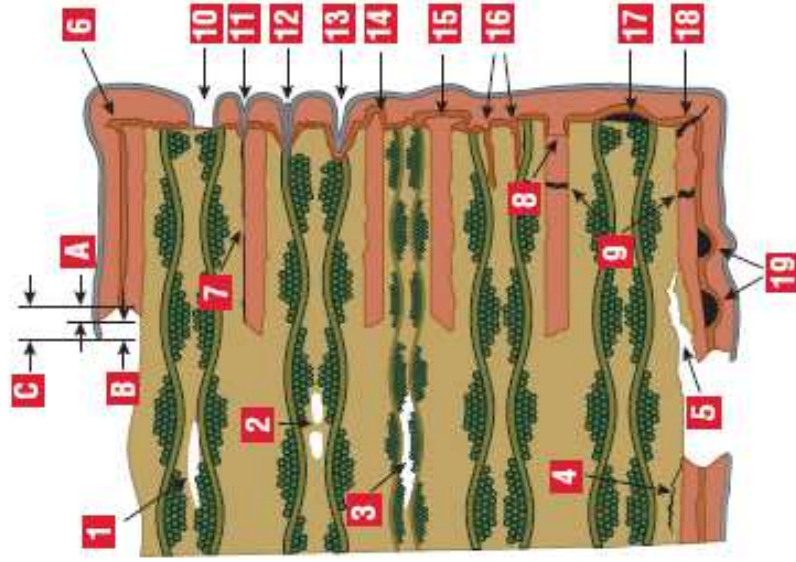
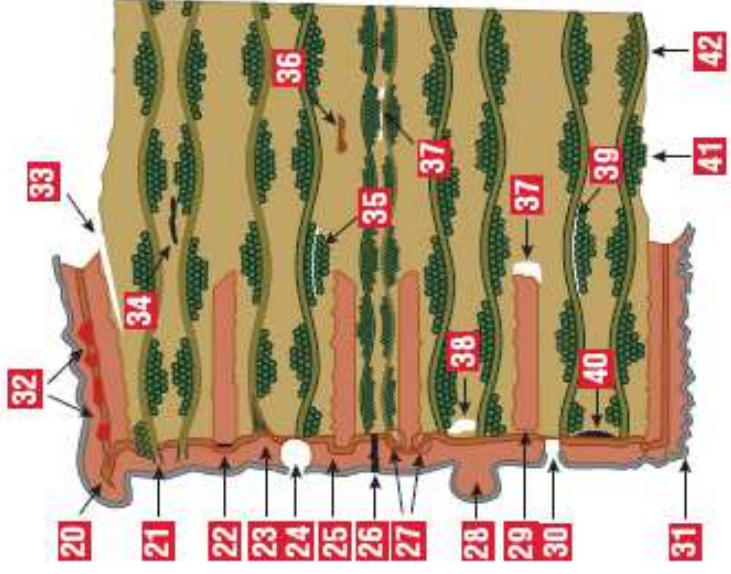
- A Undercut
- B Outgrowth
- C Overhang
- 1 (Resin) Blistering
- 2 Laminate Void
- 3 (Resin) Delamination
- 4 Pad Cratering
- 5 Lifted Land Crack
- 6 Burr
- 7 Bond Enhancement removed – "Pink Ring"
- 8 Negative Etchback
- 9 Foil Crack
- 10 Hole Plating Void
- 11 Wedge Void
- 12 Glass Fiber Void
- 13 Glass Bundle Void
- 14 Severe Etchback
- 15 Nail Heading
- 16 Drill Wall Tear/Wicking
- 17 Hole Wall Pull Away
- 18 Corner Crack
- 19 (Copper) Blistering

- 20 Burr Pushed Into Hole
- 21 Glass Fiber Protrusion
- 22 Innerlayer (Post) Separation
- 23 Wicking
- 24 Over Plating Resist Void
- 25 (Positive) Etchback
- 26 Barrel Crack
- 27 Shadowing
- 28 Nodule
- 29 Resin Smear
- 30 Copper & Over Plate Void
- 31 Burned Plating
- 32 Copper Foil Contamination
- 33 Lifted Land
- 34 Resin Crack Delamination
- 35 Crazing
- 36 Foreign Inclusion
- 37 Prepreg Void
- 38 Copper Clad Laminate Void
- 39 Measling
- 40 Resin Recession
- 41 Glass-Weave Texture
- 42 Glass-Weave Exposure
